# Observations during the fabrication of spinel optics

Joseph R. Bashe\*, Douglas L. Hibbard  
Exotic Electro-Optics, 36570 Briggs Rd., Murrieta, CA 92563;

Joseph R. Bashe, EEO; Douglas L. Hibbard, EEO, "Observations during the fabrication of spinel optics," Window and Dome Technologies and Materials XI, Randal W. Tustison, Volume 7302, Page 7302OC, 2009

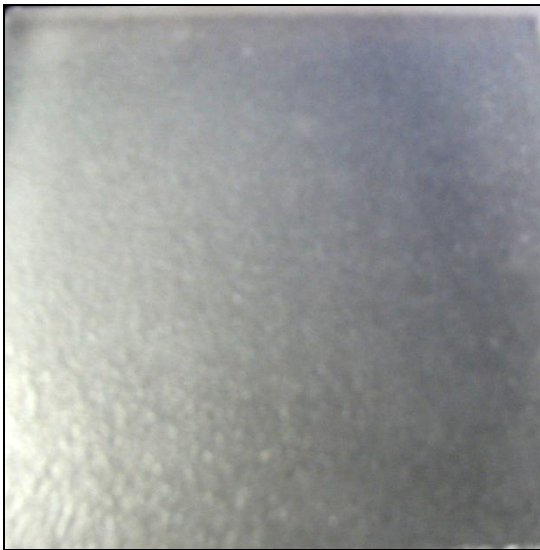
The raw material in Figure 1 was of a very coarse texture and a high degree of irregularity. The inspection polished material, shown in Figure 2, allows incoming inspection of material inclusions and haze. In the photograph, multiple inclusions are evident throughout the bulk of the material. A light hazy appearance characterizes the material. This hazy appearance is quite common in spinel material.

Figure 1. Representative photograph of raw, unprocessed spinel material.

As explained in the section *Description of Evaluation*, investigations began with visual inspections of the samples. Figure 1 and Figure 2 are representative photomicrographs depicting the difference in the visual appearance and surface characteristics of incoming materials.

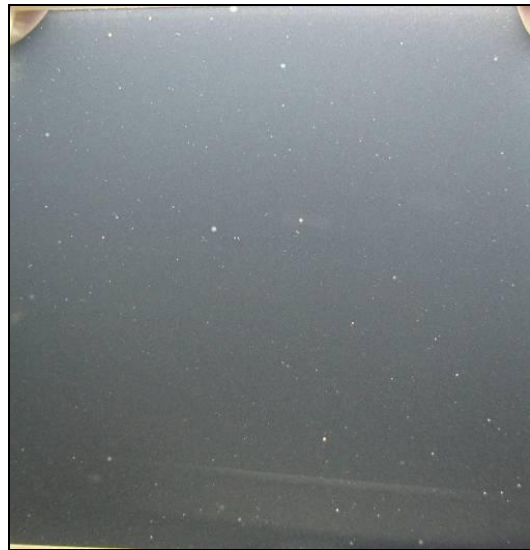
Figure 2. Representative photograph of inspection polished spinel material.

Two of the inclusions seen in Figure 2 above are examined more closely in Figure 5 and Figure 6. In these figures, two separate examples of inclusions near the surface of the inspection polished spinel material are shown. These inclusions are quite large, the left measuring 0.02" in diameter and the right measuring over 0.06" when the outer halo is included. The chemical make-up of these inclusions is not known, but they are thought to be artifacts of the material consolidation process.

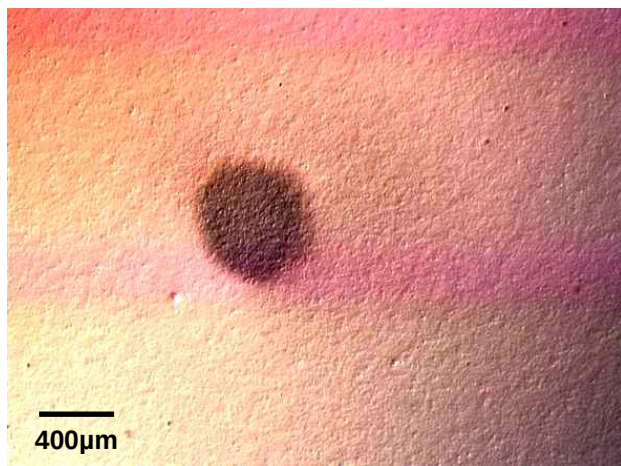
Figure 5. 0.02" diameter inclusion on the surface of inspection polished spinel sample. 50X.

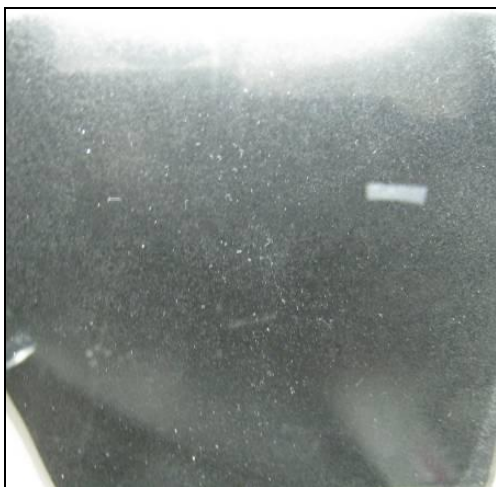
Figure 11. Photograph of polished spinel.

Figure 11 through Figure 14 are representative photographs showing the visual appearance of the samples from all three vendors after polishing. In Figure 11 and Figure 13, the material is observed to be generally clear but has a speckled appearance attributable to both inclusions and granularity in the material. In Figure 12, the sample exhibits a less

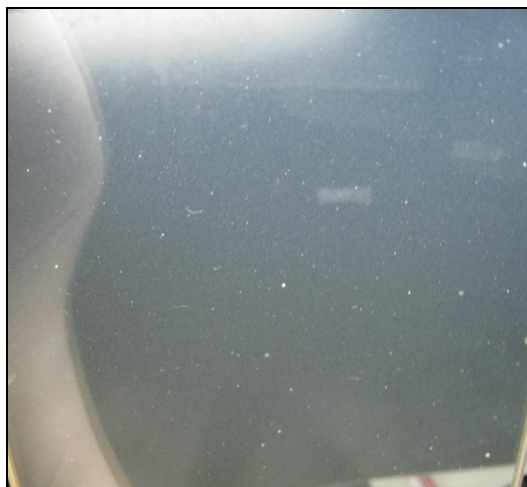
Figure 12. Photograph of polished spinel.

speckled, but hazy appearance. For reference, Figure 14 is given to show that only under intense lighting do all of the defects in the material become obvious, whereas under normal lighting some of the larger inclusions are visible but the material is quite transparent to the naked eye. The transmittance of these materials will be quantified in the *Optical Performance* results later in the section.
